Drive Shaft Oil Seal

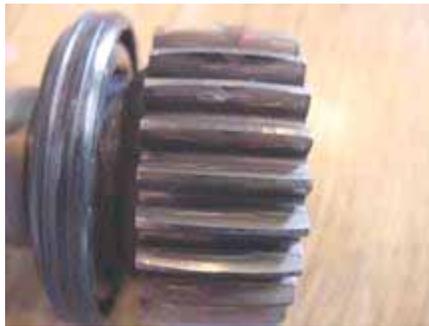
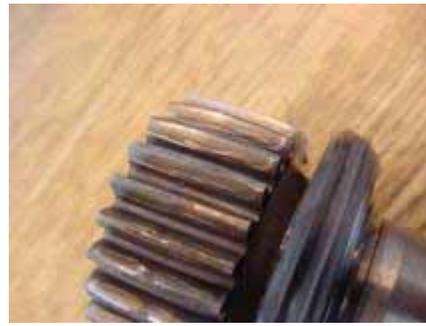
Whilst washing all the parts, the "grease" on the drive shaft's splines, turned out to be ATF mixed with the fretted material particles from the splines. It formed a paste, which blocked the two oil-feeding holes, restricting and eventually blocked the oil flow and acted as a grinding paste. This worn the drive shaft's splines, as this was the softer material of the two splines. The splines on the differential's side had no sign of wear.

Old shaft's splines

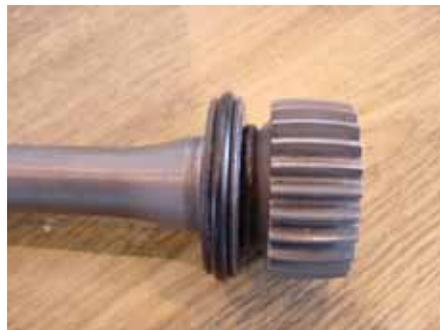
New shaft with seal & spacer

I used Teflon, machined a disc with a groove on the inside and outside, to accommodate two o-rings. The ID o-ring fits onto the oil seal landing on the shaft and the outside o-ring fits on the differential's oil seal landing in the input spline-cup. I spaced the seal on the driveshaft with the use of an o-ring, to get a tight fit on the washer and circlip.

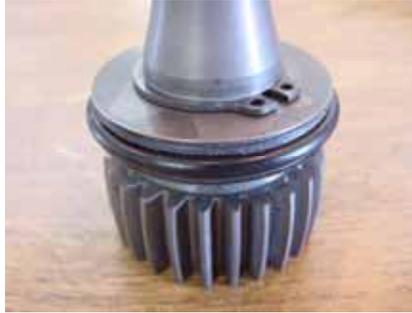
New shaft assembly

I replaced all the bearings on the differential according to the manual and filled it with SAE80/90 gear oil.

After that, I checked the oil level periodically, as I would order a new oil seal if necessary. It's been now 5000km later and the seal is still working perfectly - no oil lost.
